Asbestos Management Survey
32-43 Glenville Close
Royal Wootton Bassett
SN4 7EU
Re-visit Common Areas Only

Date 2nd October 2024 Expiry Date: 2nd October 2025 Prepared by K Howell Reviewed by C Jelfs

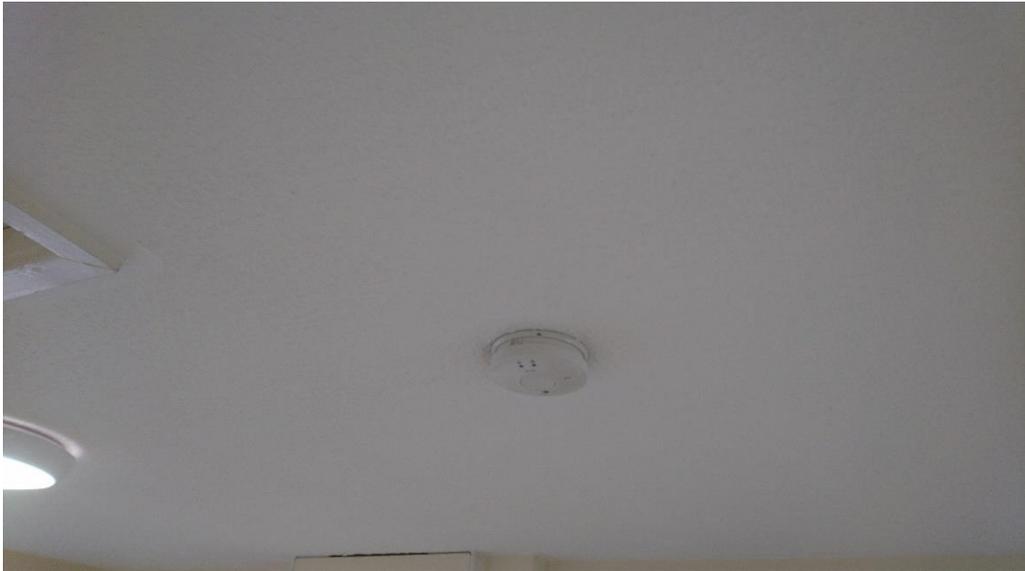
Client	
Survey Address	32-43 Glenville Close Royal Wootton Bassett SN4 7EU
Location/Item	101 Landing textured coating to ceiling
Reference Number	1
Sample Number	002
Photo Details

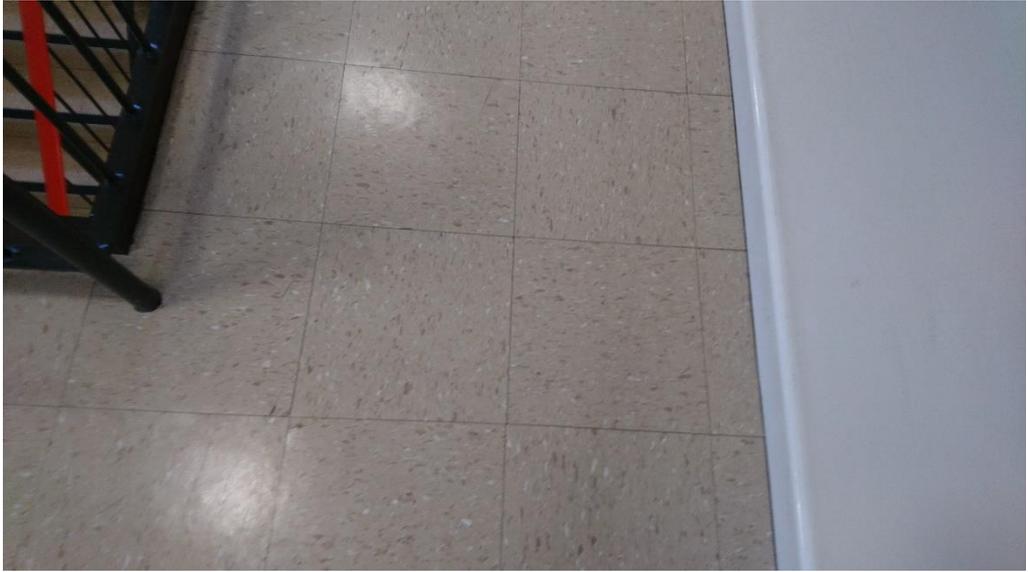
Client	
Survey Address	32-43 Glenville Close Royal Wootton Bassett SN4 7EU
Location/Item	101 Landing floor tiles & adhesive including stairs
Reference Number	2
Sample Number	003
Photo Details

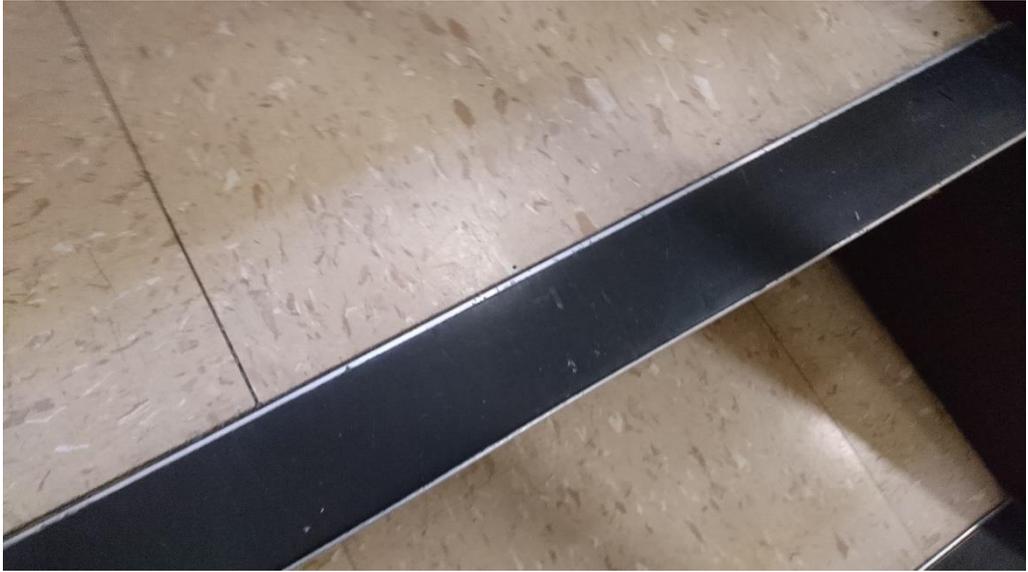
Client	
Survey Address	32-43 Glenville Close Royal Wootton Bassett SN4 7EU
Location/Item	101 Landing stair nosing
Reference Number	3
Sample Number	004
Photo Details

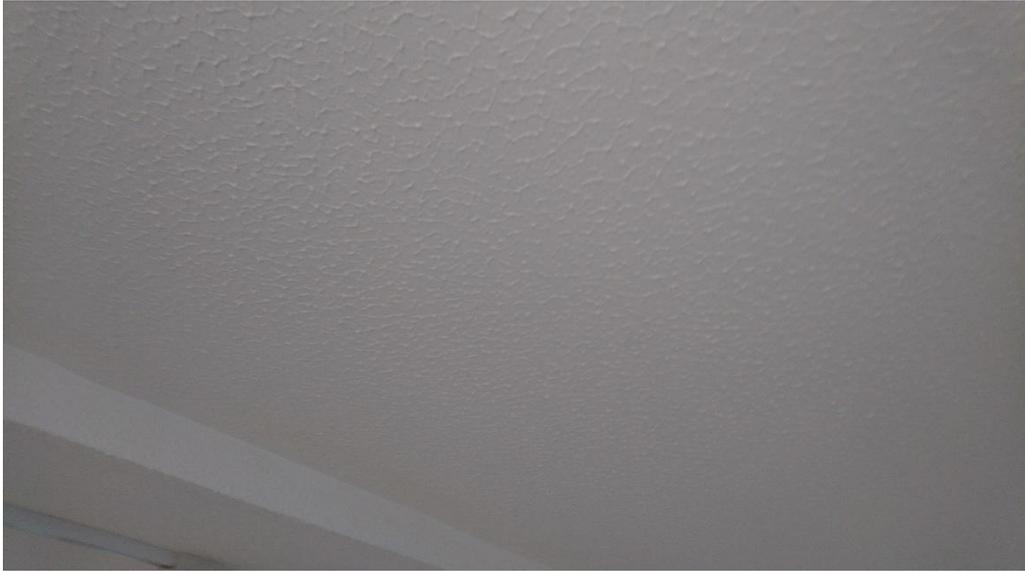
Client	
Survey Address	32-43 Glenville Close Royal Wootton Bassett SN4 7EU
Location/Item	003 Hallway textured coating to ceiling including understairs
Reference Number	4
Sample Number	Vis Sim 002
Photo Details

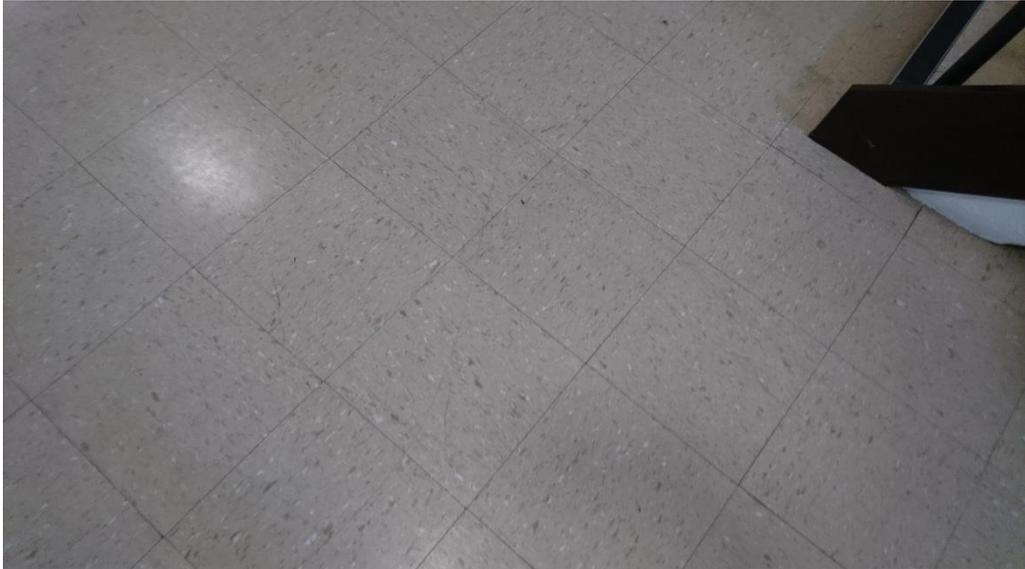
Client	
Survey Address	32-43 Glenville Close Royal Wootton Bassett SN4 7EU
Location/Item	003 Hallway floor tiles & adhesive
Reference Number	5
Sample Number	Vis Sim 003
Photo Details

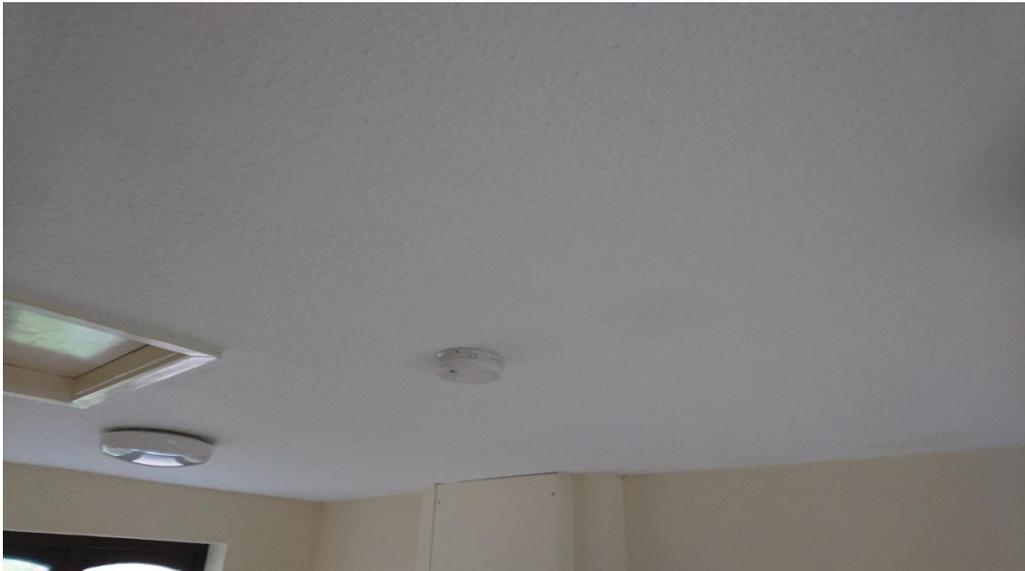
Client	
Survey Address	32-43 Glenville Close Royal Wootton Bassett SN4 7EU
Location/Item	102 Landing textured coating to ceiling
Reference Number	6
Sample Number	005
Photo Details

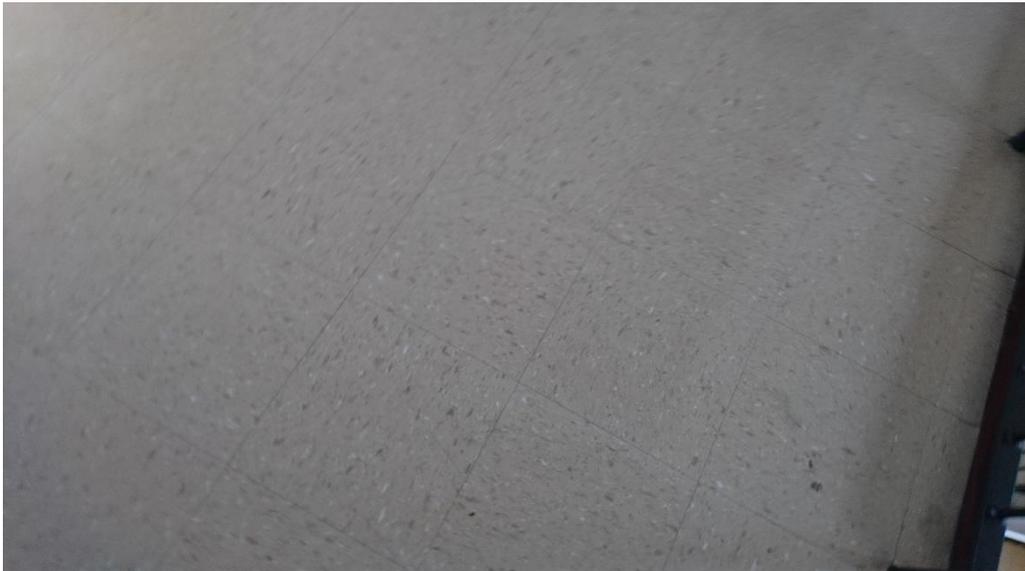
Client	
Survey Address	32-43 Glenville Close Royal Wootton Bassett SN4 7EU
Location/Item	102 Landing floor tiles & adhesive including stairs
Reference Number	7
Sample Number	Vis Sim 003
Photo Details

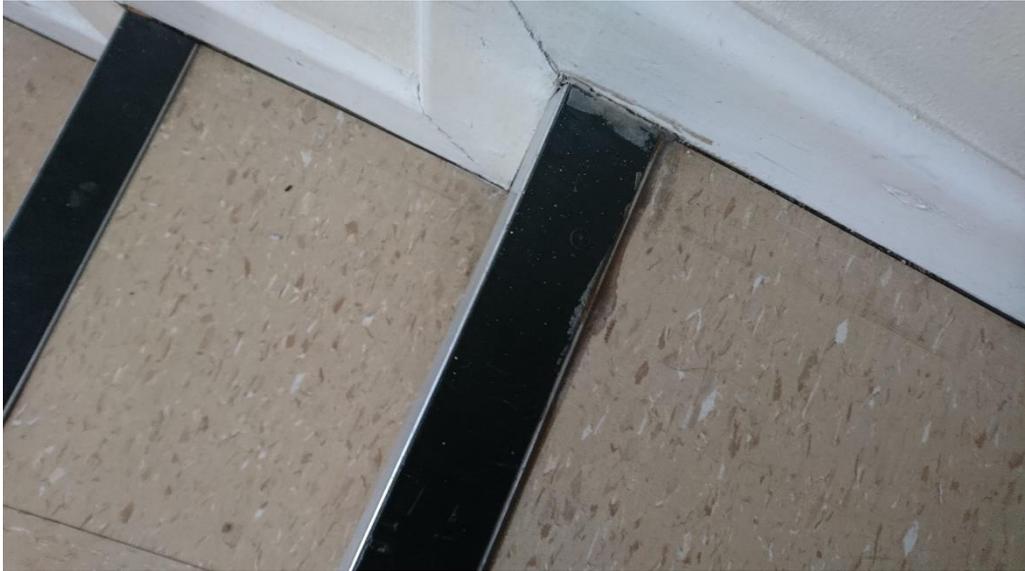
Client	
Survey Address	32-43 Glenville Close Royal Wootton Bassett SN4 7EU
Location/Item	102 Landing stair nosing
Reference Number	8
Sample Number	Vis Sim 004
Photo Details

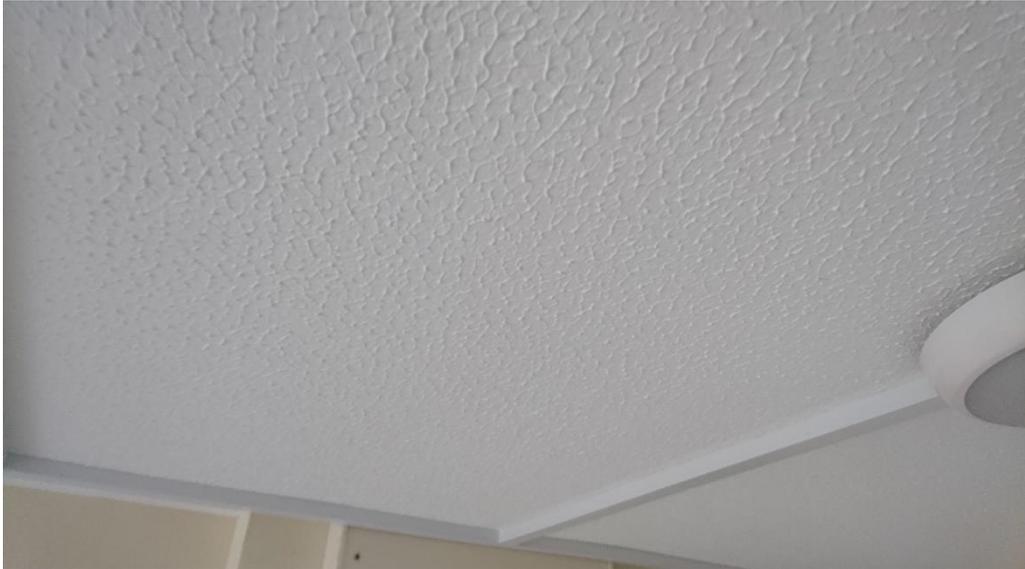
Client	
Survey Address	32-43 Glenville Close Royal Wootton Bassett SN4 7EU
Location/Item	004 Hallway textured coating to ceiling including underside of stairs
Reference Number	9
Sample Number	Vis Sim 005
Photo Details

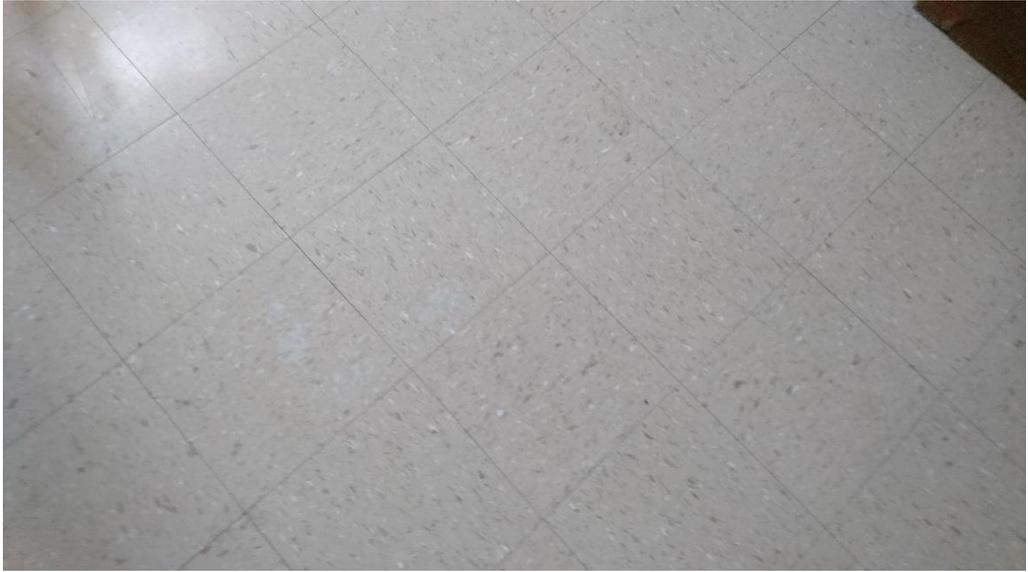
Client	
Survey Address	32-43 Glenville Close Royal Wootton Bassett SN4 7EU
Location/Item	004 Hallway floor tiles & adhesive
Reference Number	10
Sample Number	Vis Sim 003
Photo Details
