# COMBINED FIRE AND HEALTH & SAFETY RISK ASSESSMENT.

| Address of premises: | 32-43 Glenville Close,<br>Royal Wootton Bassett,<br>Swindon,<br>SN4 7EU |
| Date of fire risk assessment: | 18 <sup>th</sup> September 2024/ Reviewed September 2025 |

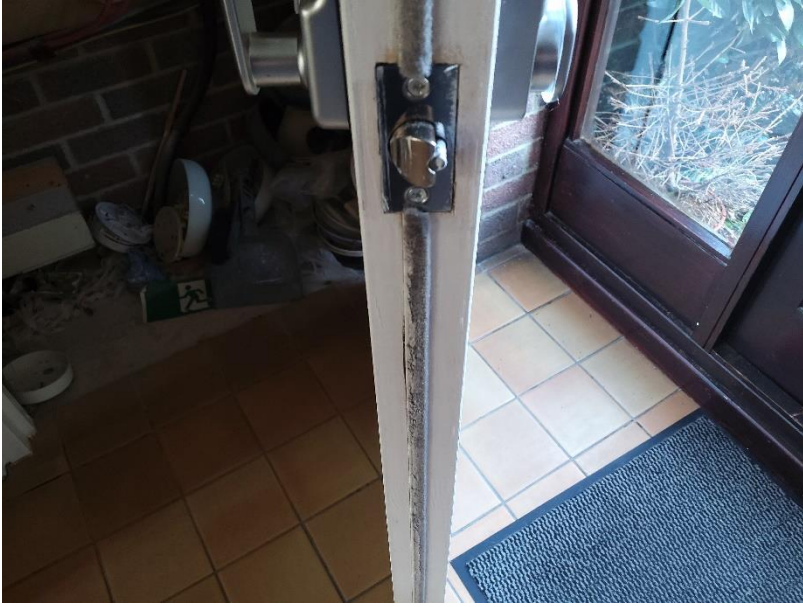
| <p>04</p> | <p>It was noted during this fire risk assessment that the cold brush smoke seals on the electrical intake cupboard doors within entrance two were painted which could affect the integrity of the seals. It is therefore recommended that the RP instructs a suitably qualified and competent contractor to replace these seals with new cold seals in order to protect the means of escape as per Fire Safety (England) Regulation 2022 Fire Door Guidance Section 6.7F.</p> | <p>2</p> | <p>B</p> | <p>Action Complete</p> |

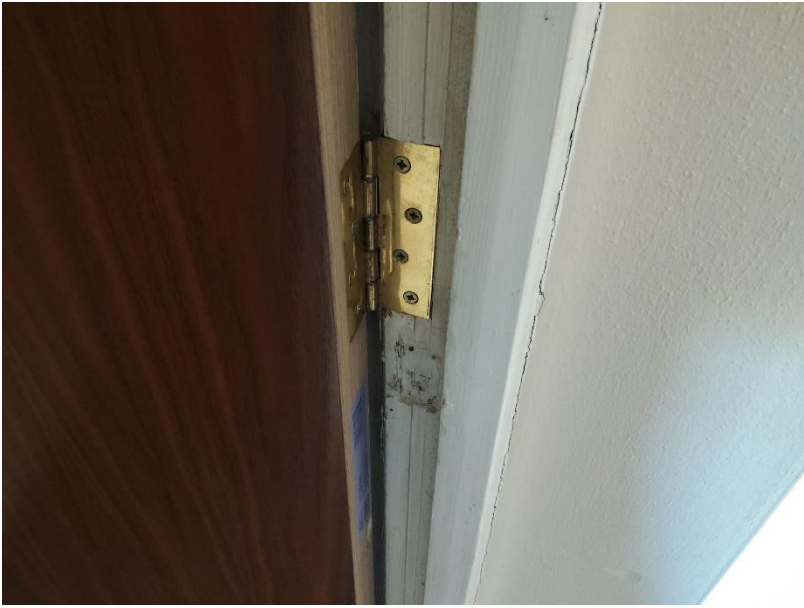
| 05 | <p>As per section 33.2 of Fire Safety in Purpose-Built Block of Flats a type 1 fire risk assessment requires us to conduct a fire door survey on a sample of flat front doors. Doors to flats 33 and 34 were surveyed during this sample and had the following deficiencies, no cold smoke and intumescent smoke seals, three times non fire rated hinges. Flat 34 also had no self-closing device.</p> <p>It is essential that each flat entrance door is a suitable fire door, providing a minimum of thirty minutes fire resistance, hung on three grade 13 hinges and having a functioning self-closing device fitted that positively closes the door on the latch, together with smoke and intumescent seals. It is recommended therefore that the RP instruct a suitably qualified and competent contractor to conduct a fire door inspection to all flat entrance doors and communal area doors providing advice on suitability. Any shortcomings identified by this inspection should be addressed as a priority by upgrading or replacing the door.</p> <p>Flat entrance doors, communal area doors, the seals and the self-closing devices should then be subjected to an annual inspection and maintenance schedule.</p> | 1 | B | <p>Action required</p> <p>Upgrades to be considered by RP. Inspection of doors to be undertaken on or before next FRA.</p> <p>Apartment owners are responsible for their individual apartment door.</p> <p>DH provide fire safety notice to owners via website and email.</p> |

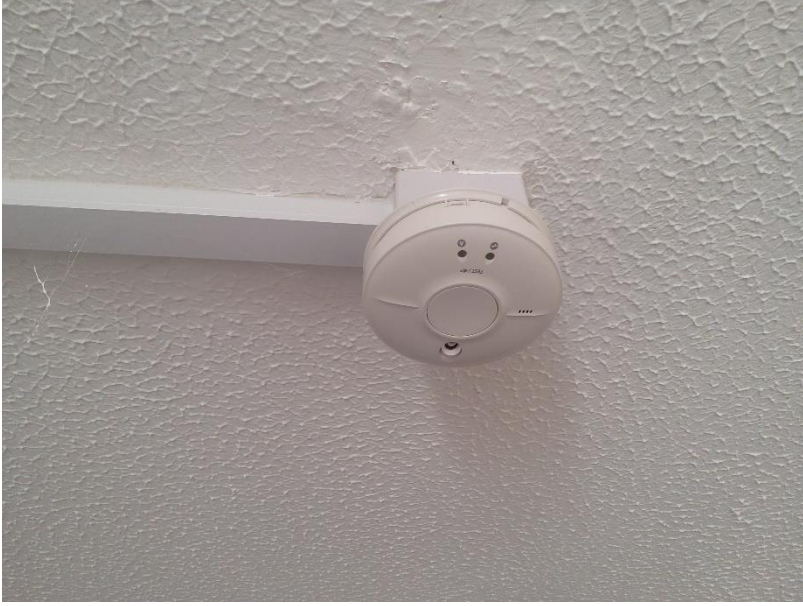
| 07 | <p>It was noted during this fire risk assessment that hard wired smoke detectors were installed within the premises. This could be considered as an overprovision for this purpose-built block of flats implementing a stay put evacuation policy. Consideration could be given by the RP as to their removal. This is in line with current fire safety guidance for purpose-built flats.</p> | 3 | C | <p>Action required</p> <p>RP to consider this advice and action accordingly.</p> |

| <p>It was noted during this fire risk assessment that hard wired smoke detectors were installed within the premises. This could be considered as an overprovision for this purpose-built block of flats implementing a stay put evacuation policy. Consideration could be given by the RP as to their removal. This is in line with current fire safety guidance for purpose-built flats.</p> <p>Each flat is responsible for their own fire precautions and it is recommended that the RP advise each resident of the importance of installing smoke detectors within their flat. One battery operated smoke detector in the lobby of each flat would be the minimum provision, however mains powered smoke detectors, each with a battery backup, installed within the escape route of each flat, in all rooms that communicate with the escape route and a heat detector within the kitchen, interlinked to form a BS5839-6: 2019 Grade D detection system with LD2 coverage would be the preferred and safest option for each occupant.</p> | | |
